**BUREAU OF SHIPS GROUP
TECHNICAL INSPECTION REPORT**

OPERATION CROSSROADS.
U.S.S. LCT's 705, 816, 818, 874, 1013,
1078, 1112, 1113

TEST ABLE

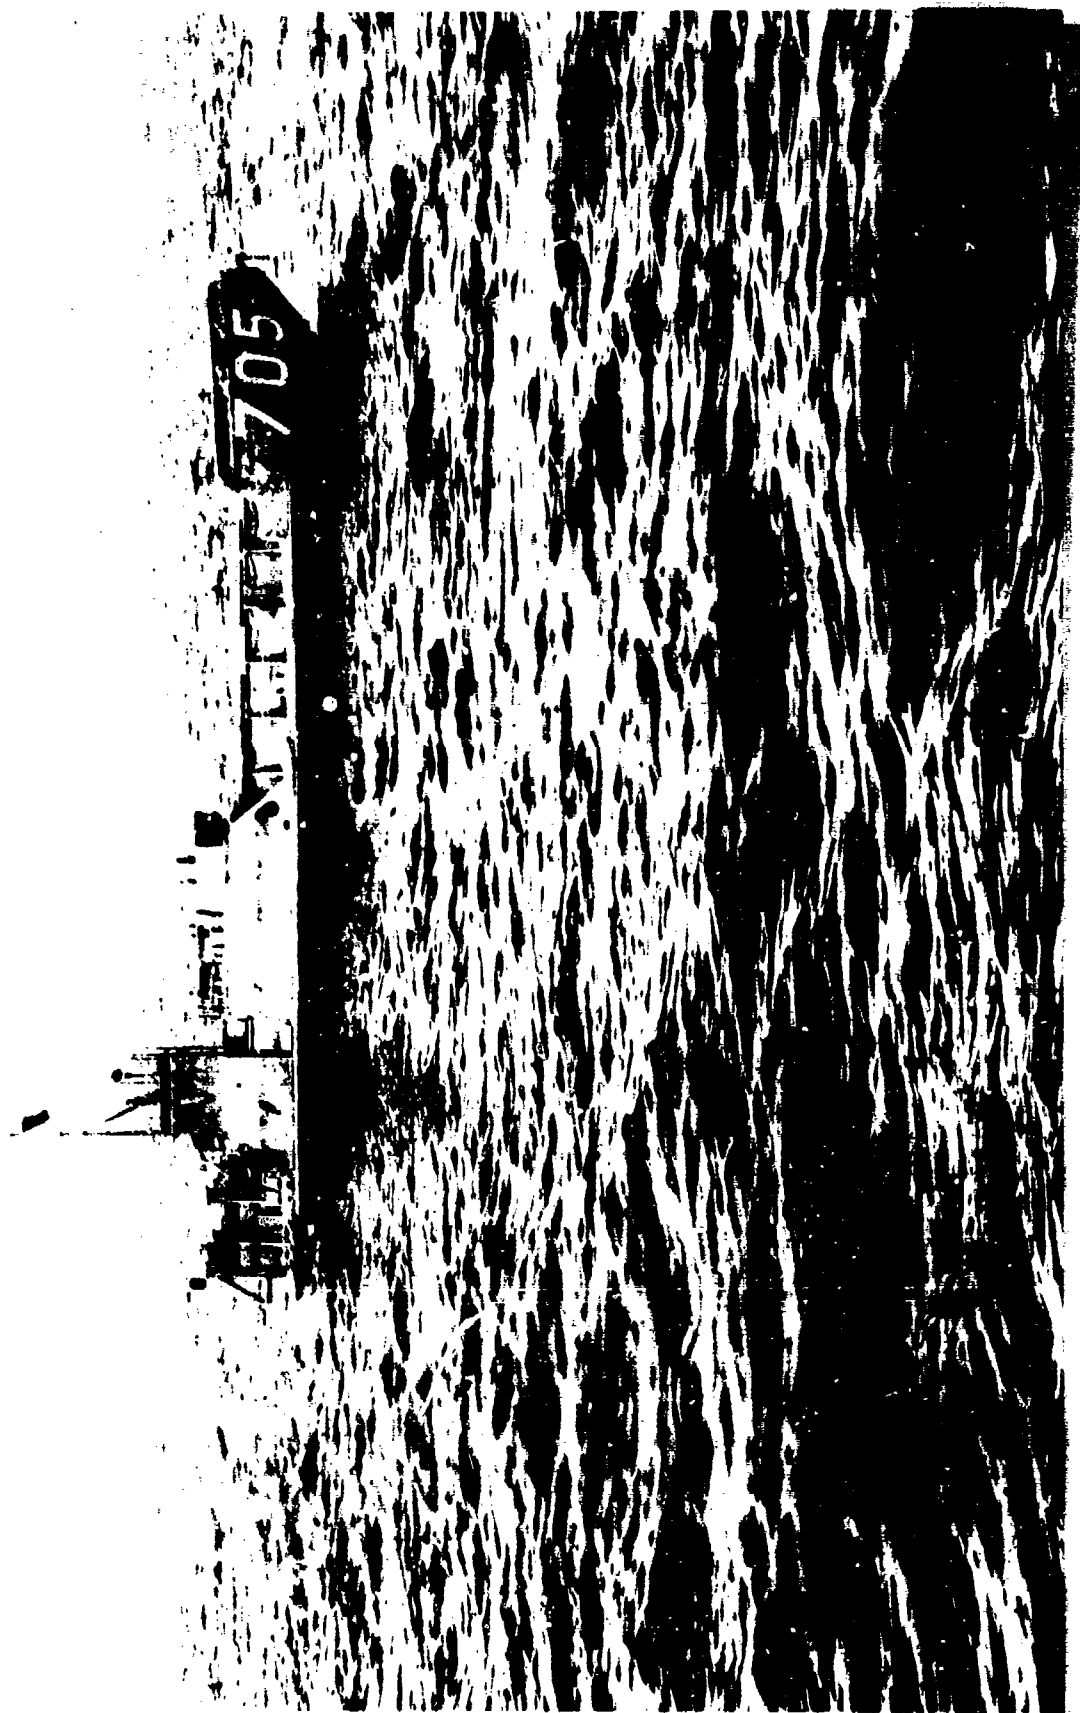
AA-CR-227-87-42. View from starboard beam after Test A.

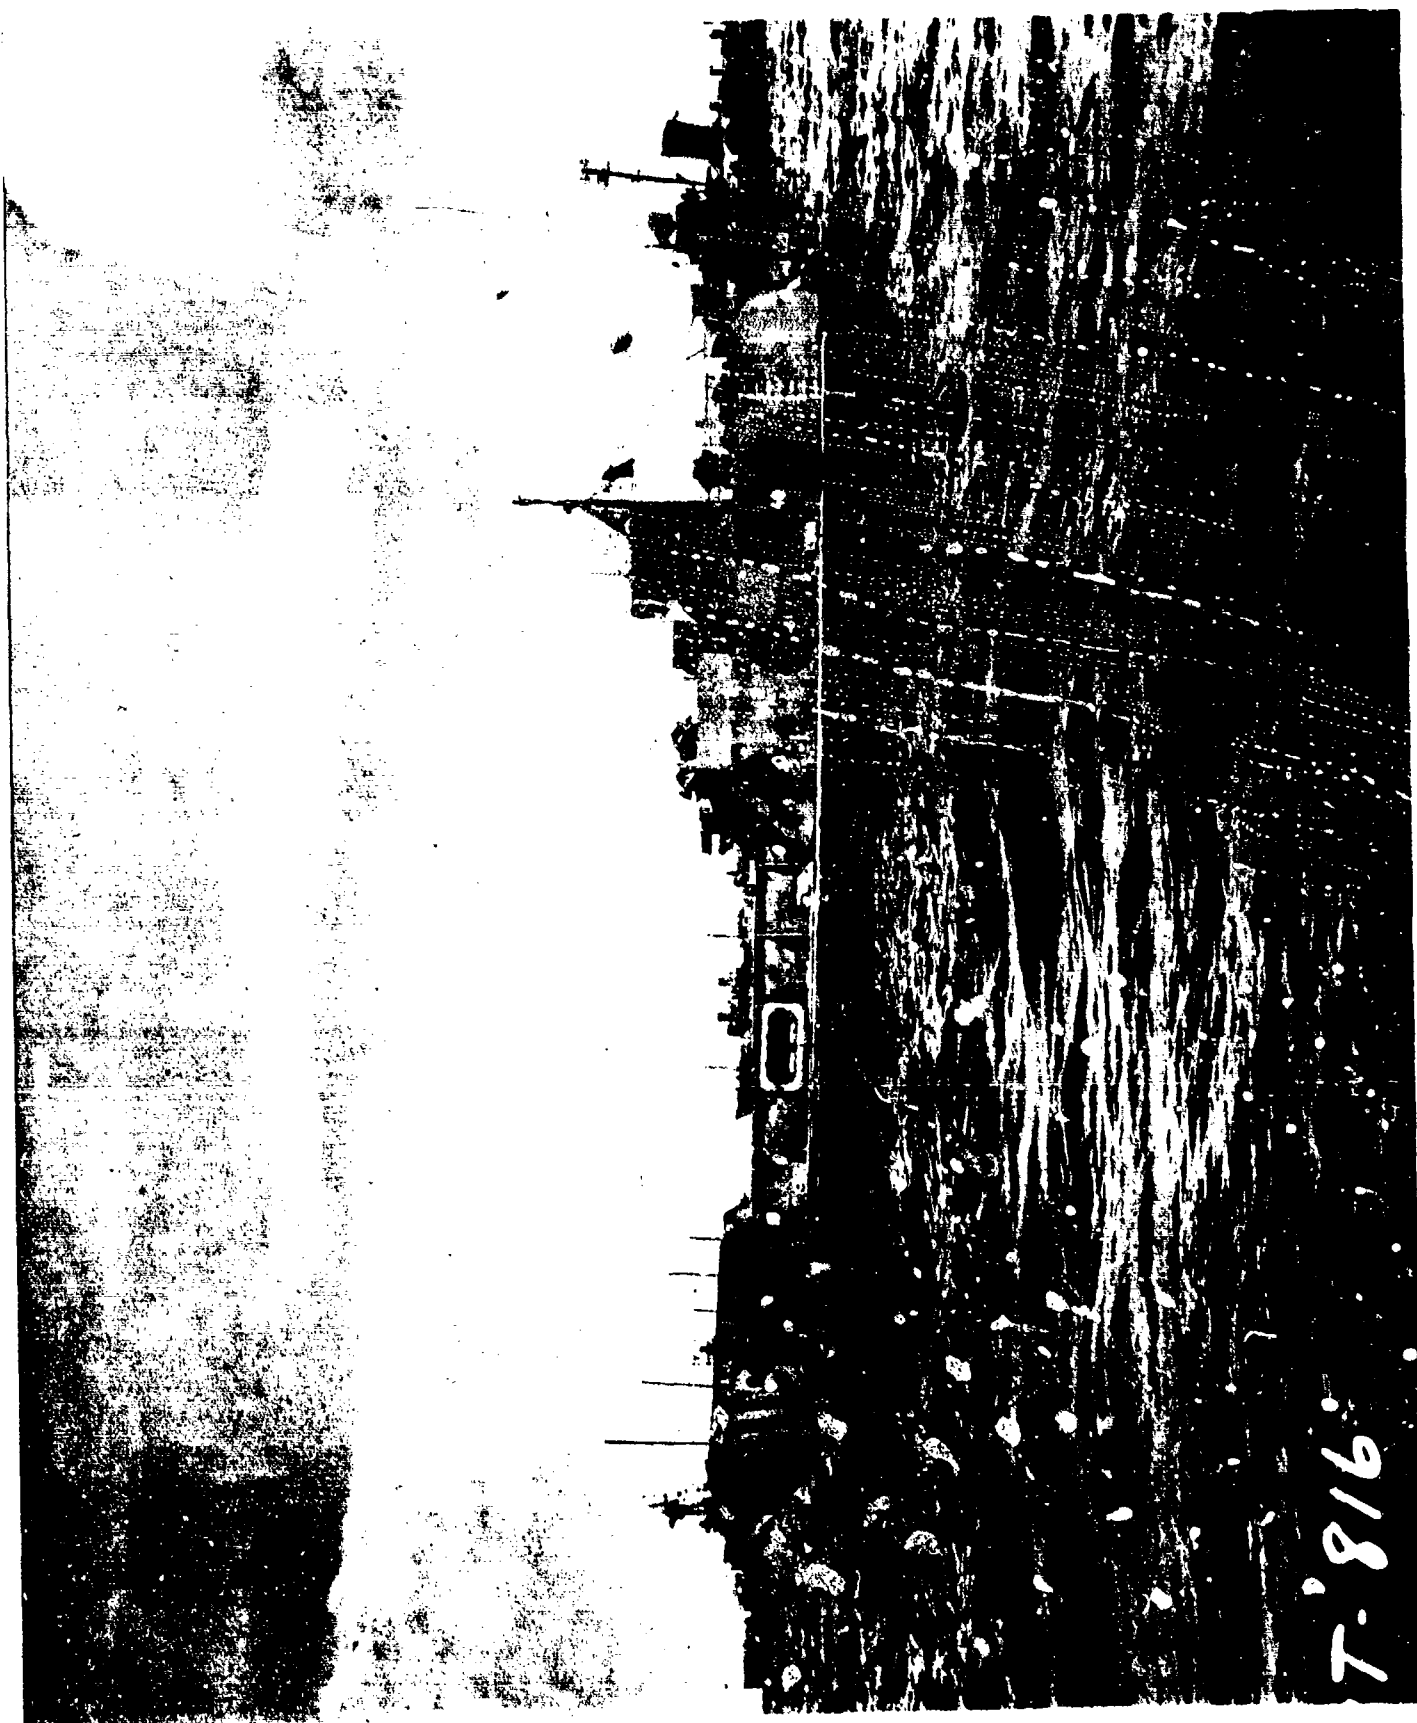
AA-CR-218-2889-9. View from off port beam after Test A.

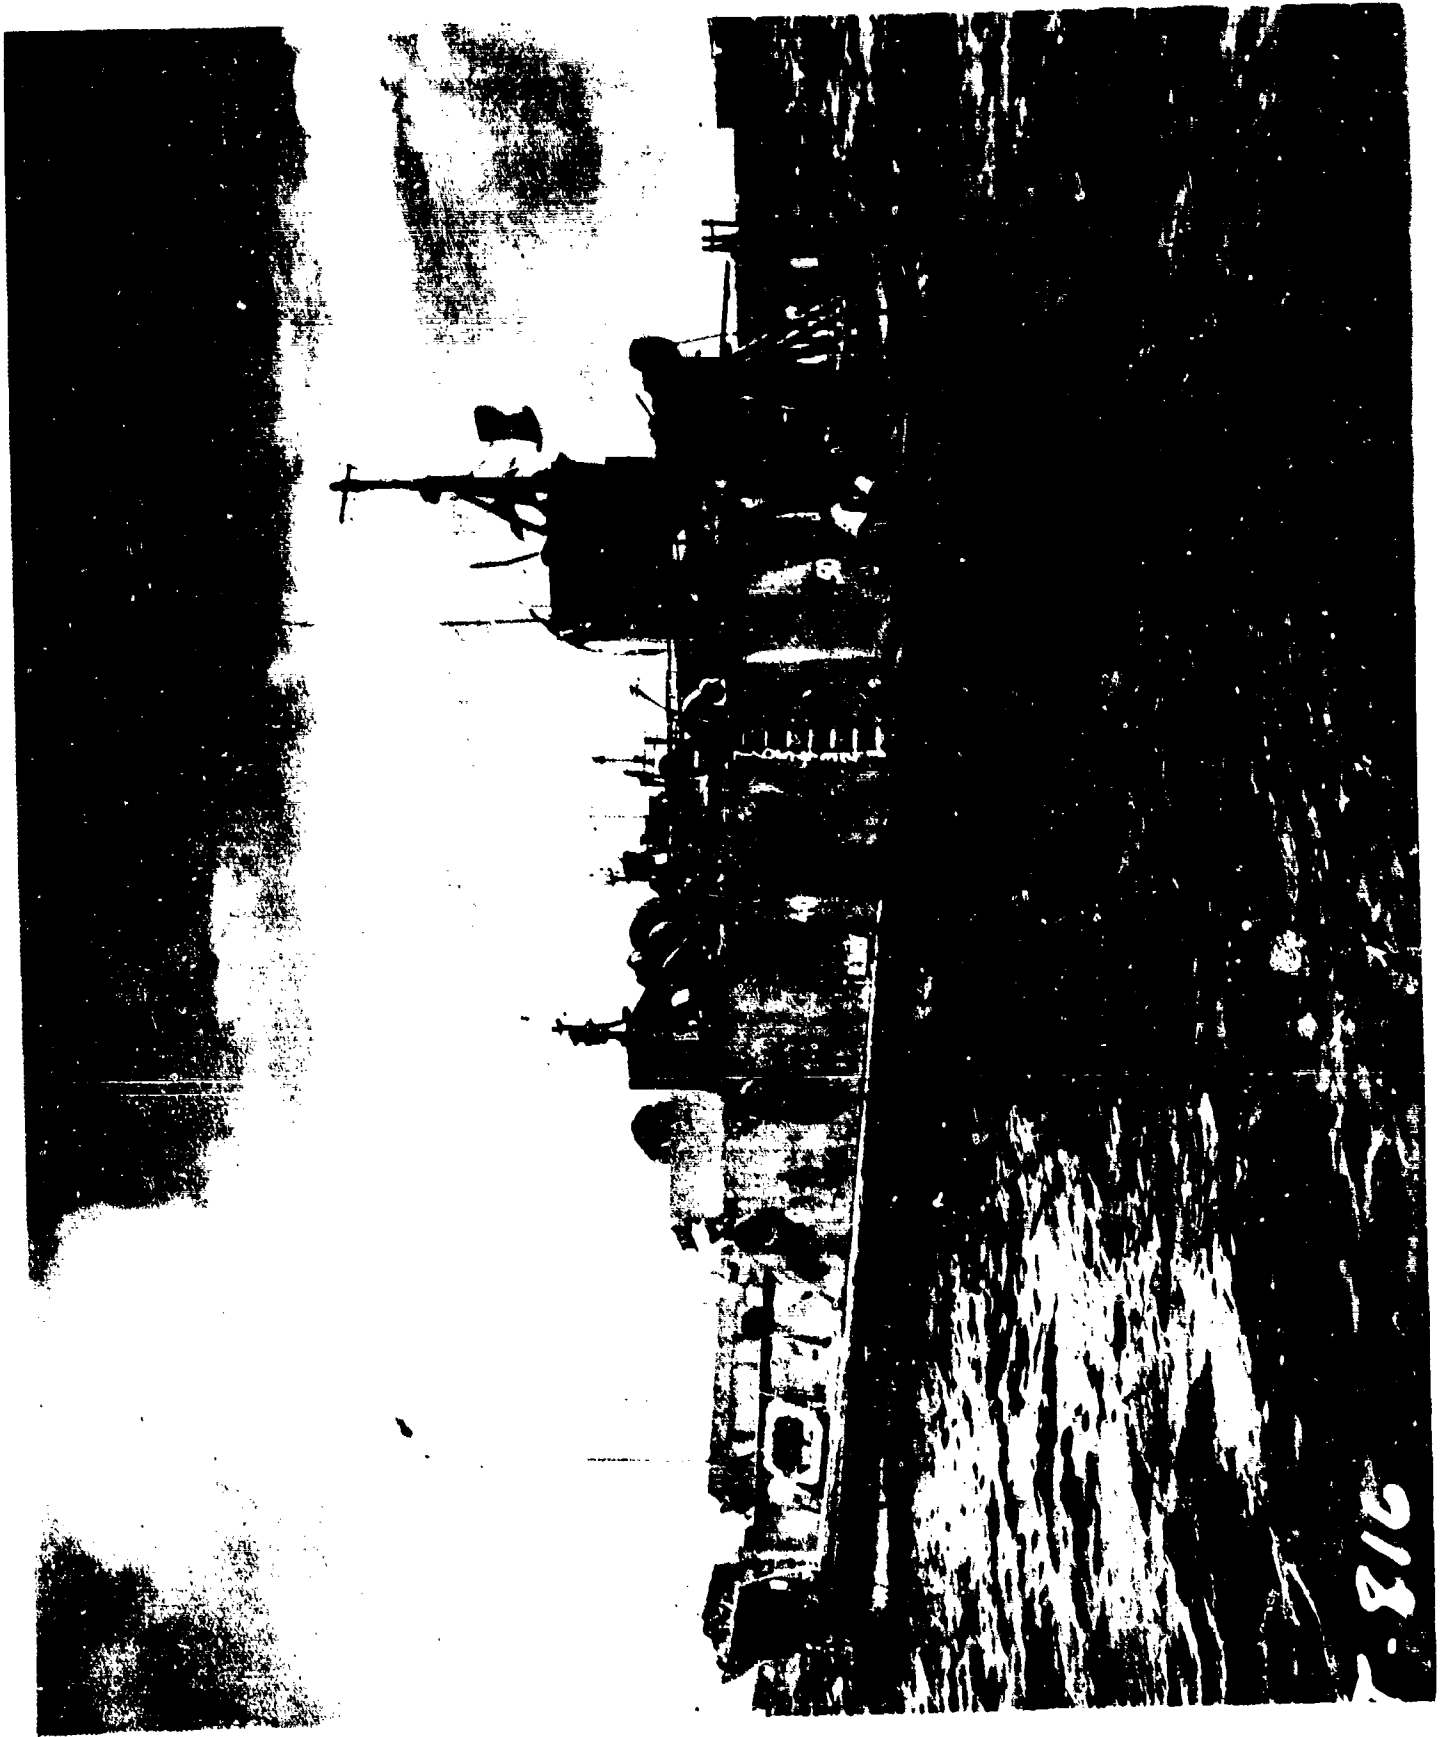
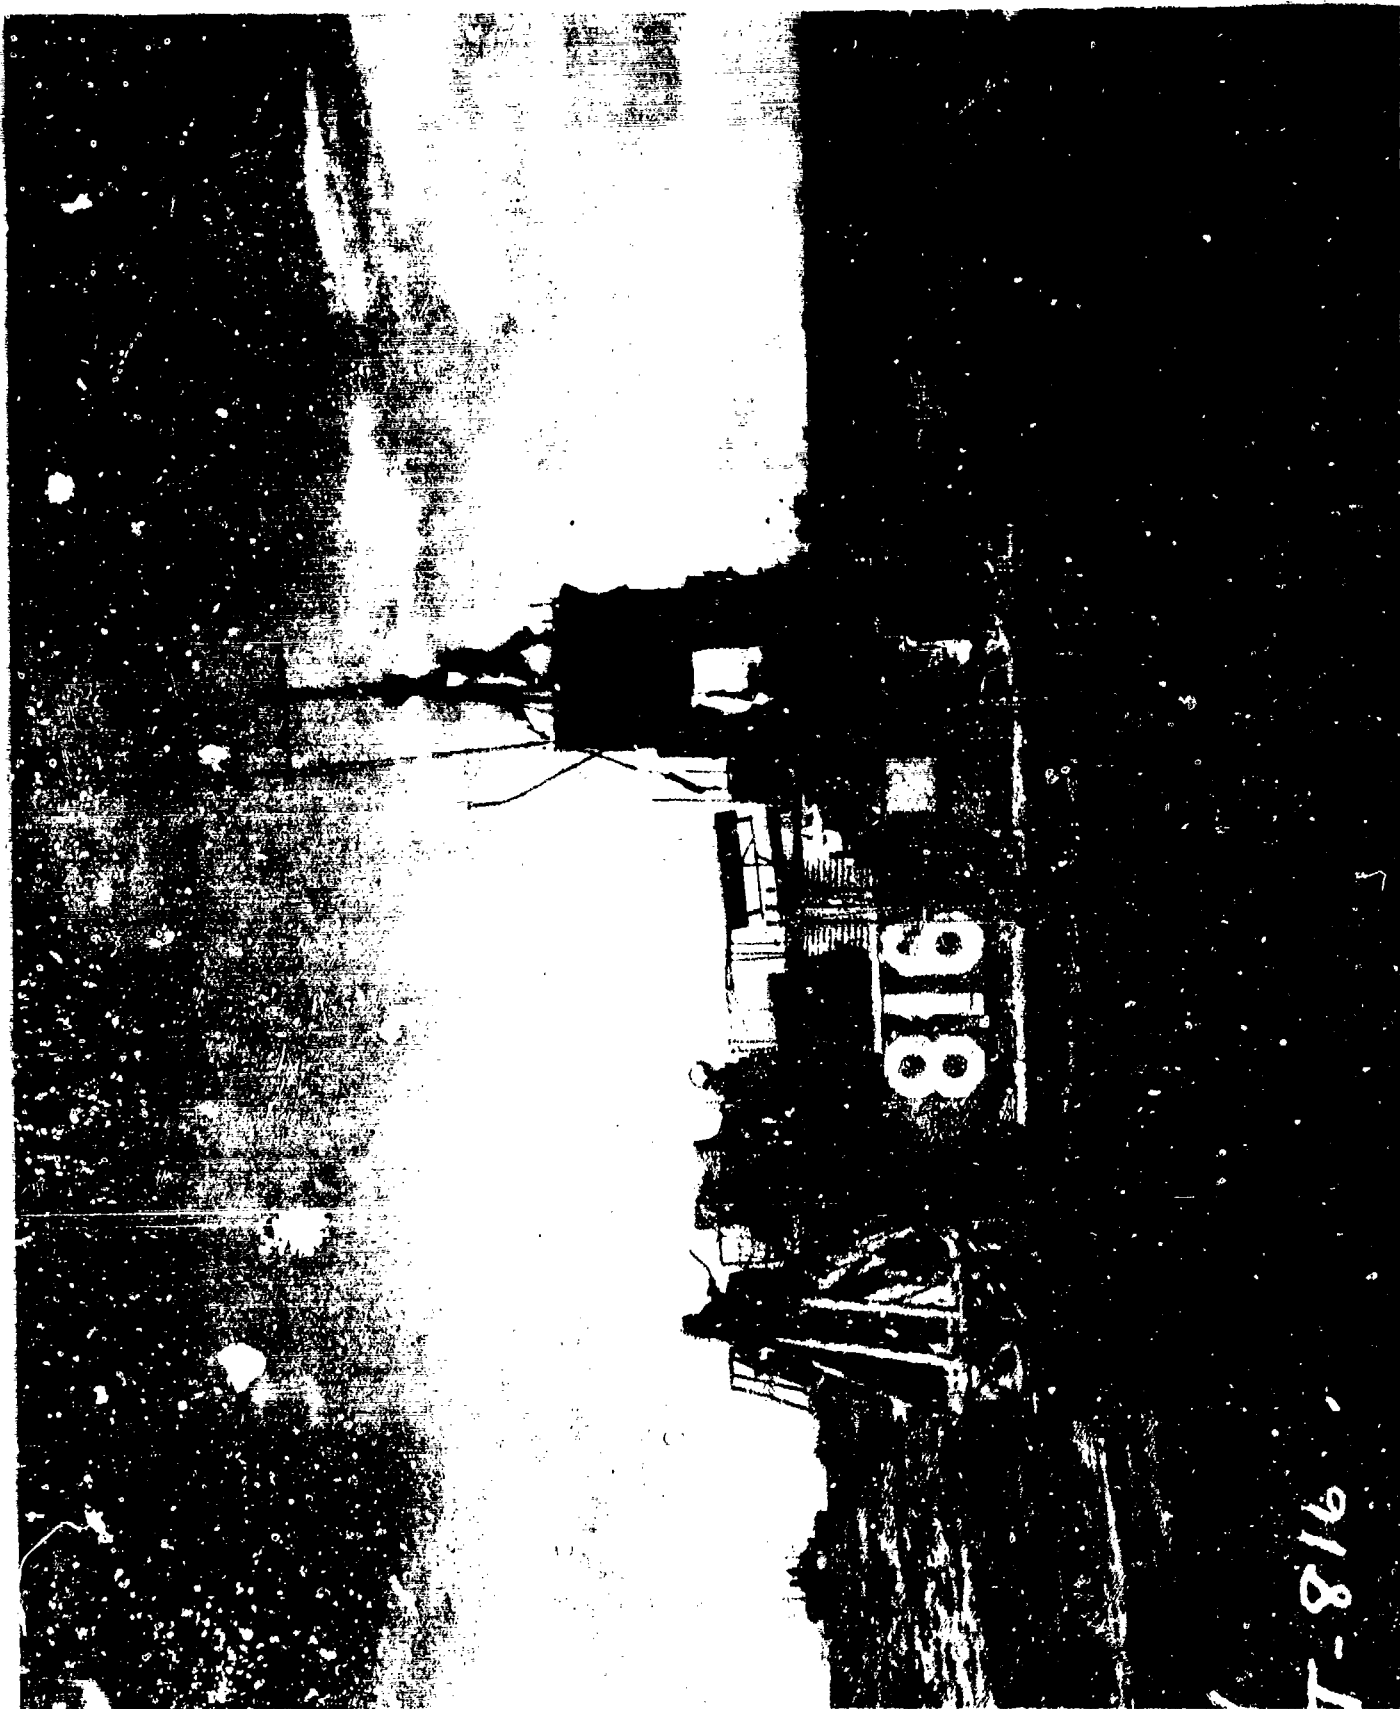
The wooden mast is nearly burned through just below the yardarm. (Photos 2889-6, 7, and 8, pages 46, 45, 44). On the after end of the house top port, a coil of rubber covered electric cable burned. The wheelhouse after bulkhead is slightly dished. The after bulkhead of the starboard deck house is dished slightly. The angle framework of the canvas covered flagbag is severely distorted. The bridge awning is collapsed. Canvas wind screens on the bridge are torn.

AA-CR-218-2889-8. View from off port quarter after Test A.

AA-CR-218-2889-7. View from astern after Test A.

AA-CR-218-2889-6. View from off starboard quarter after Test A.

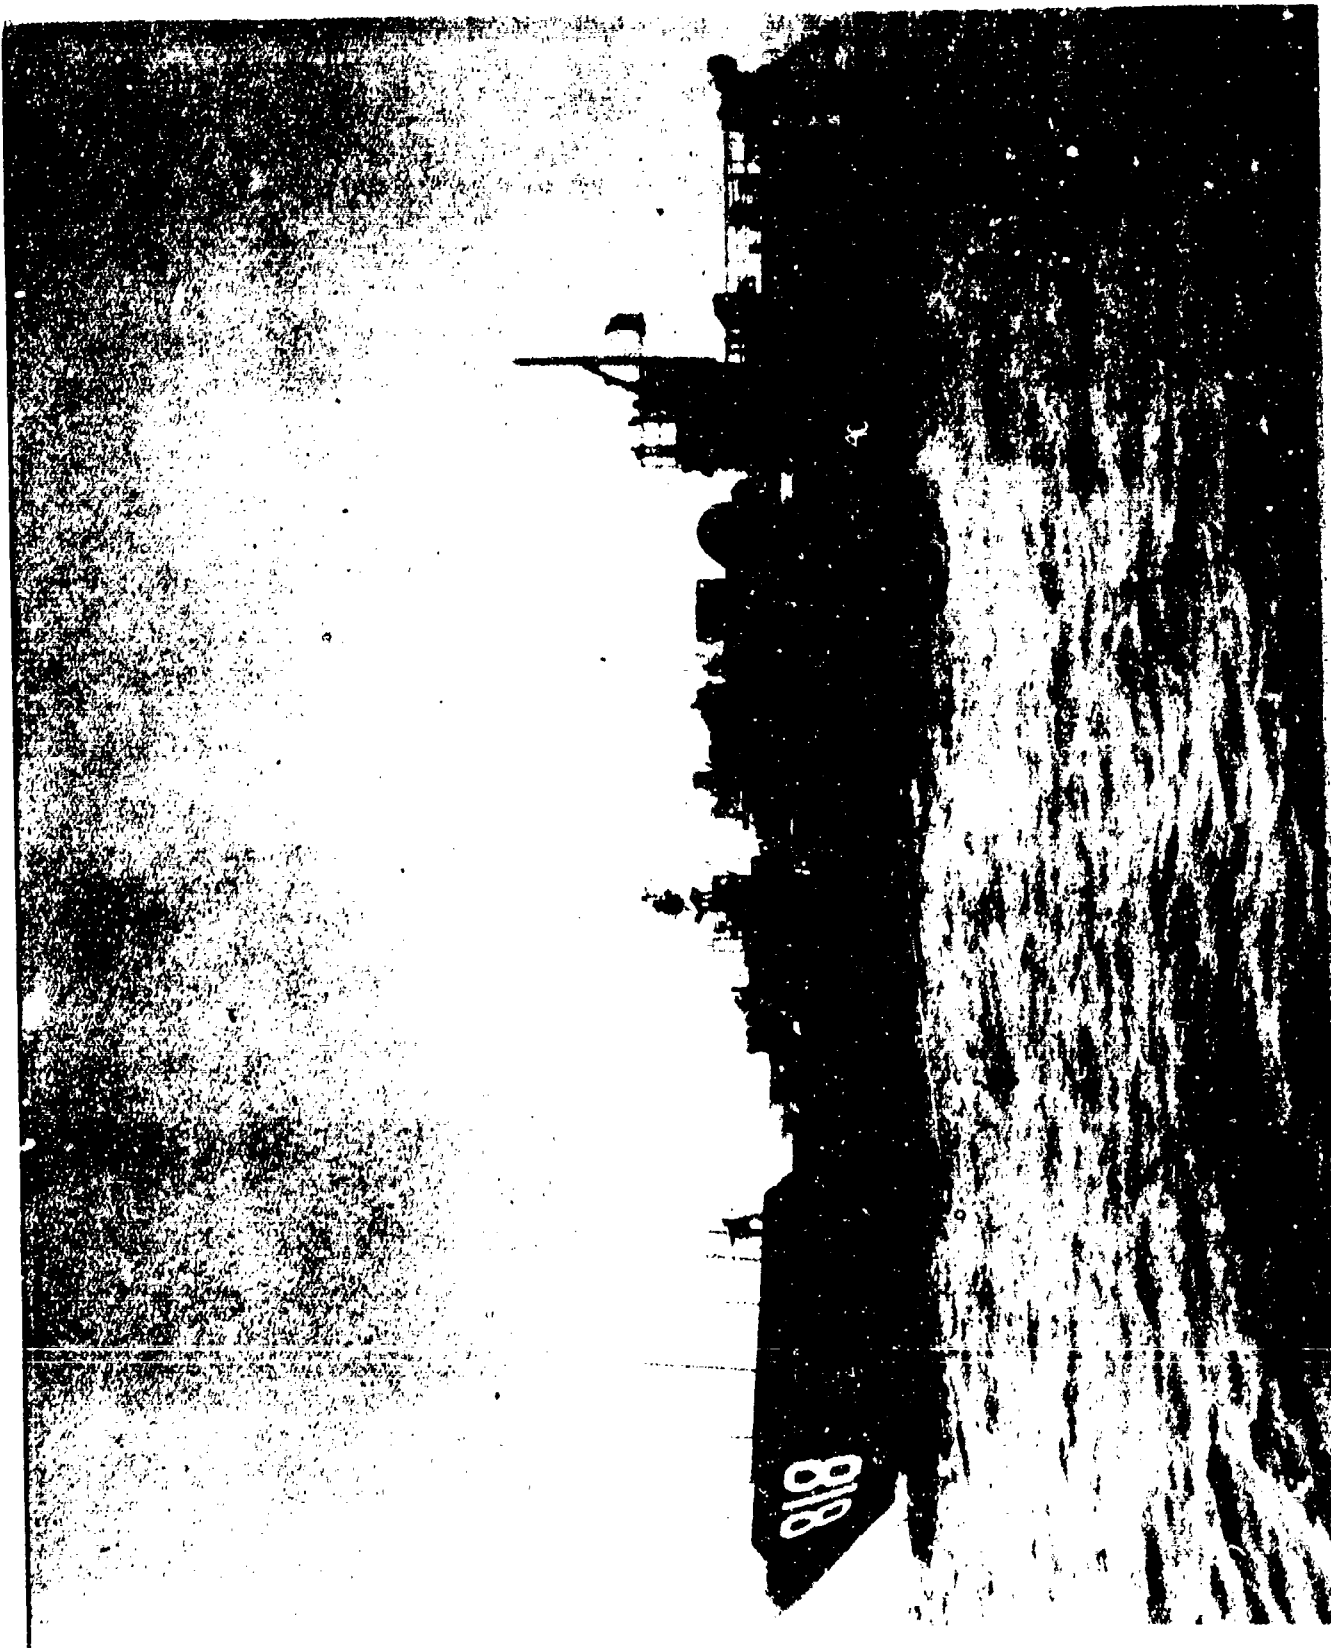
AA-CR-227-92-27. View from port beam after Test A.

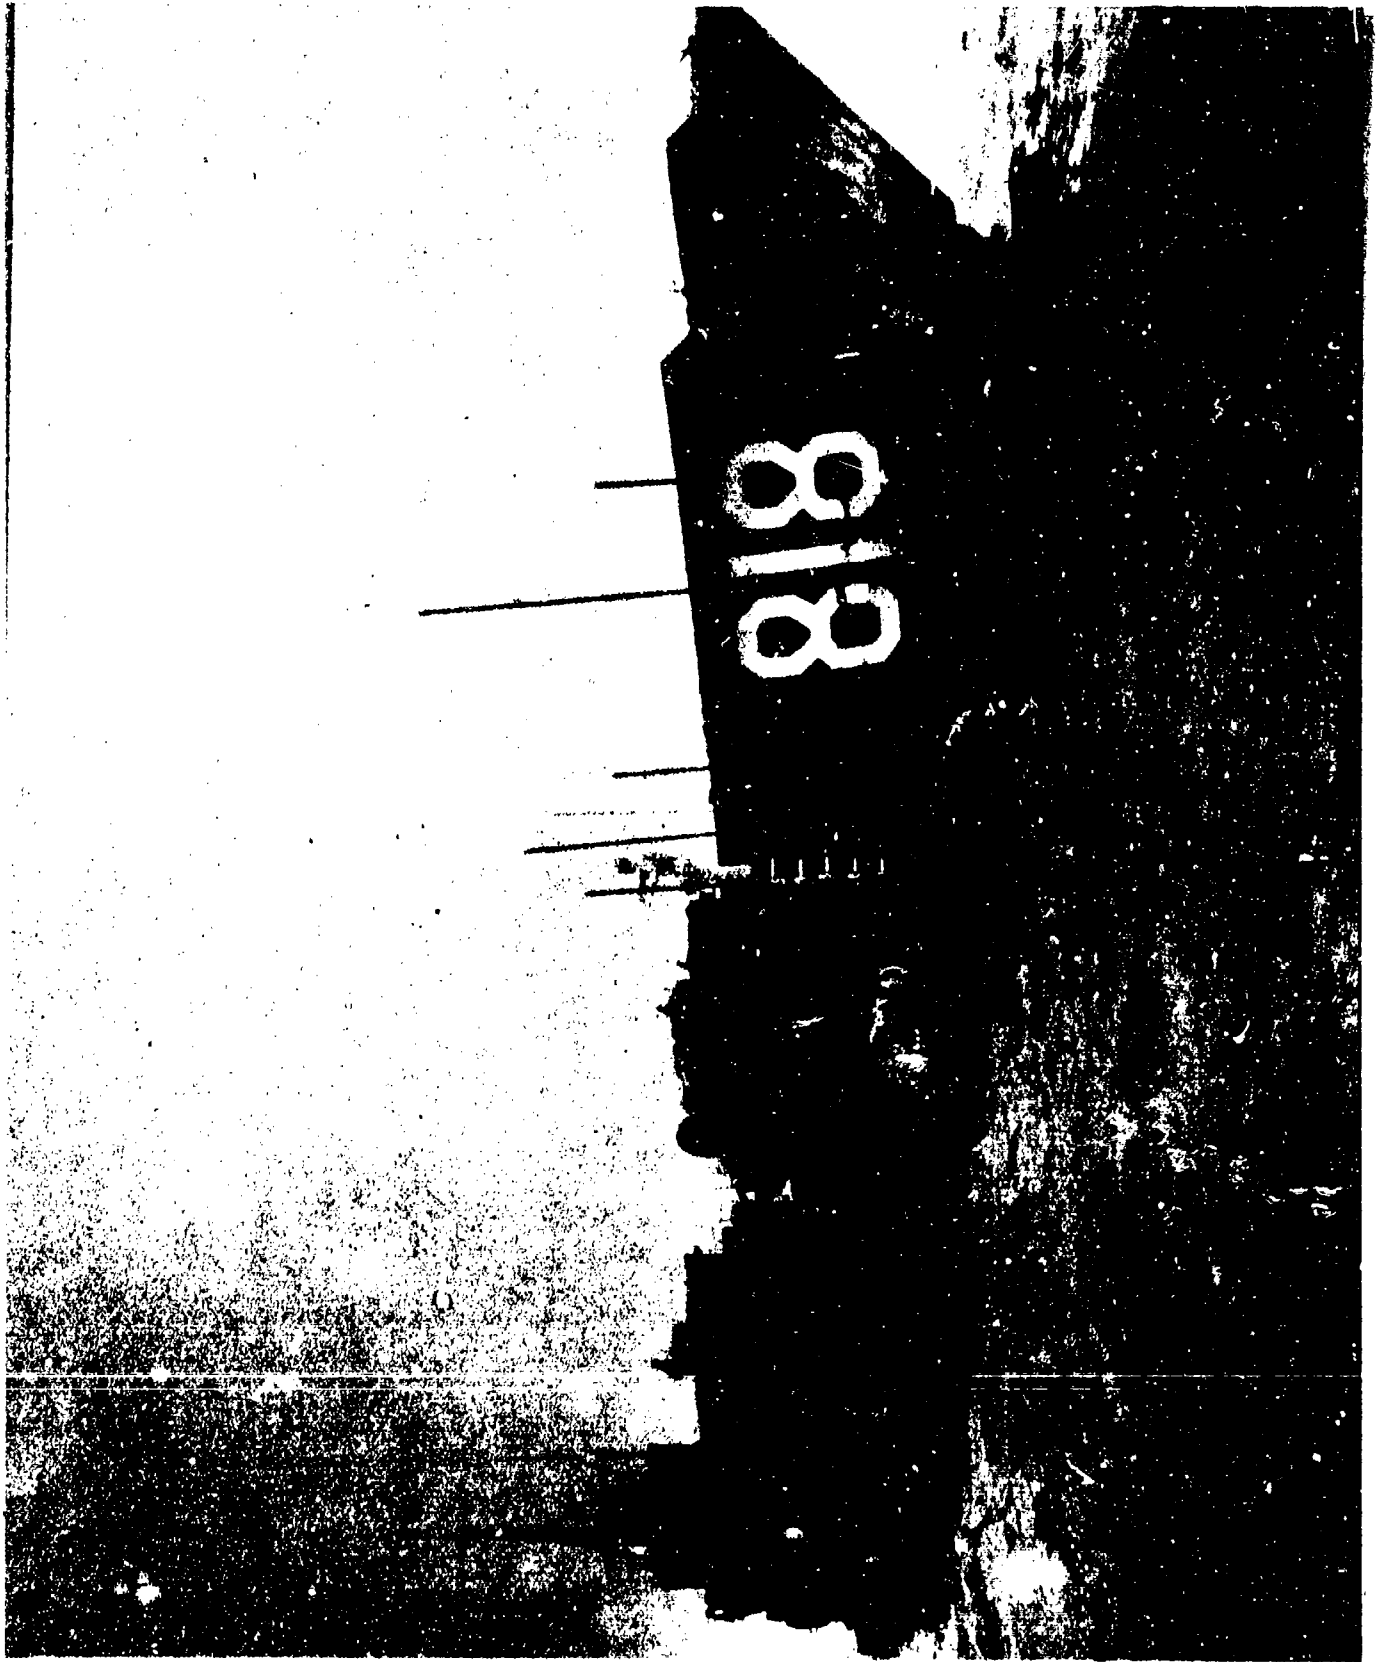
AA-CR-227-92-22. View from starboard bow after 'Test A.

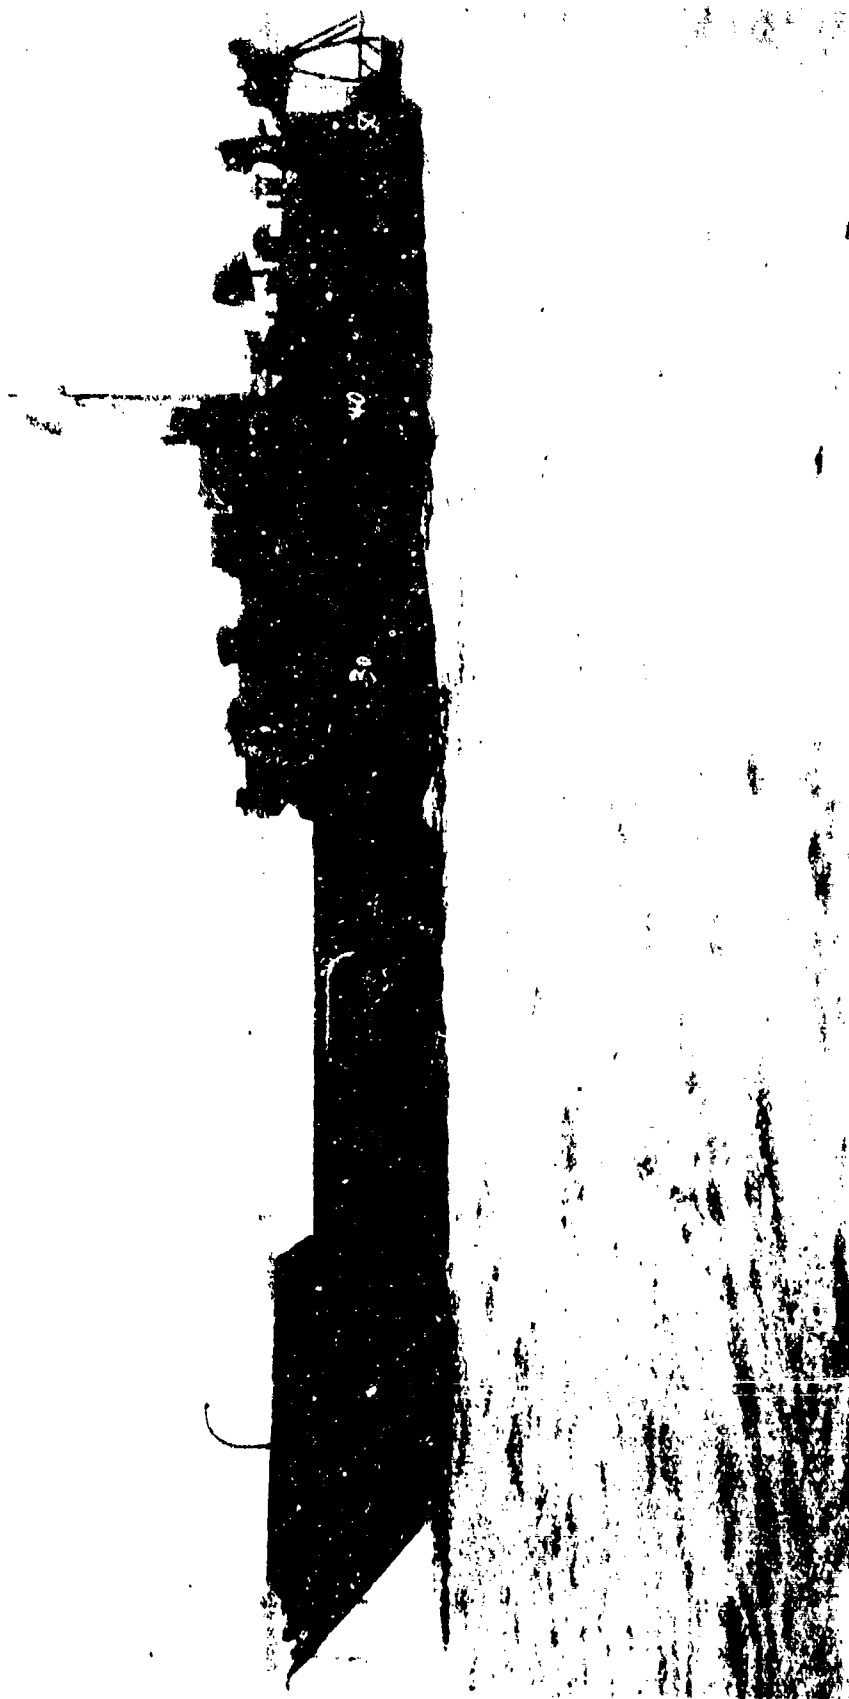
AA-CR-227-92-18. View from port beam after Test A.

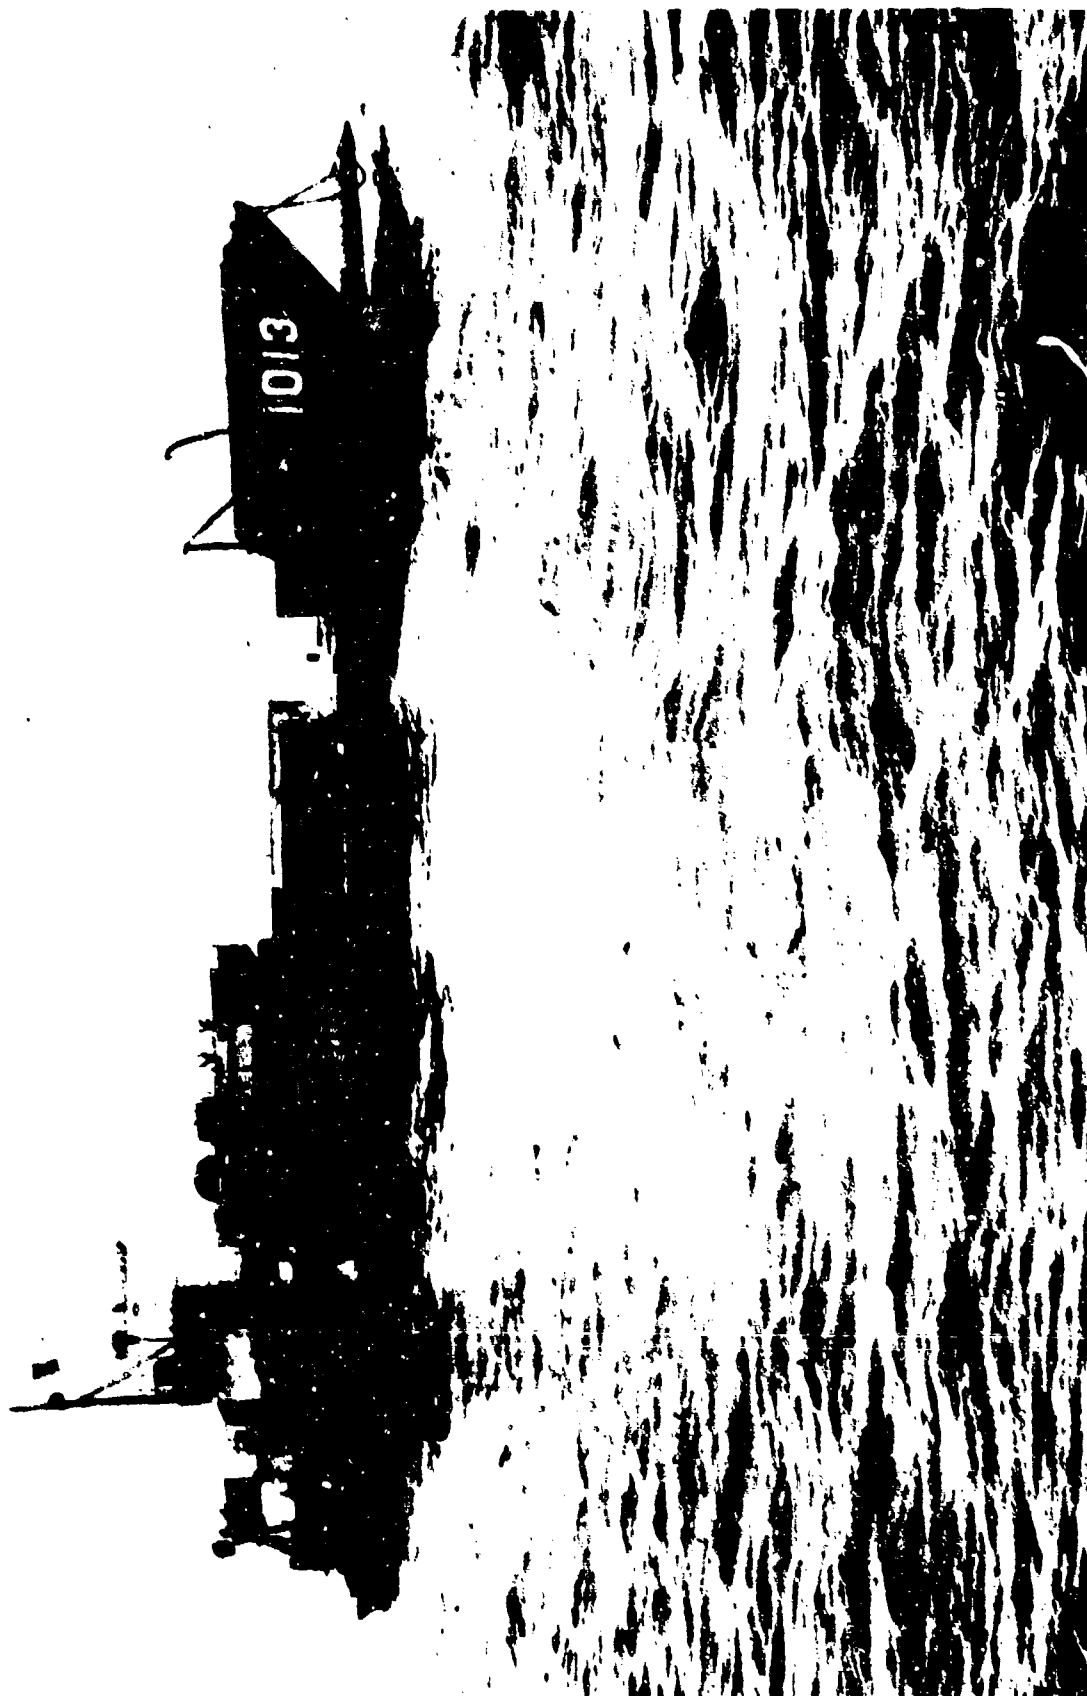
AA-CR-227-87-49. View from starboard beam after Test A.

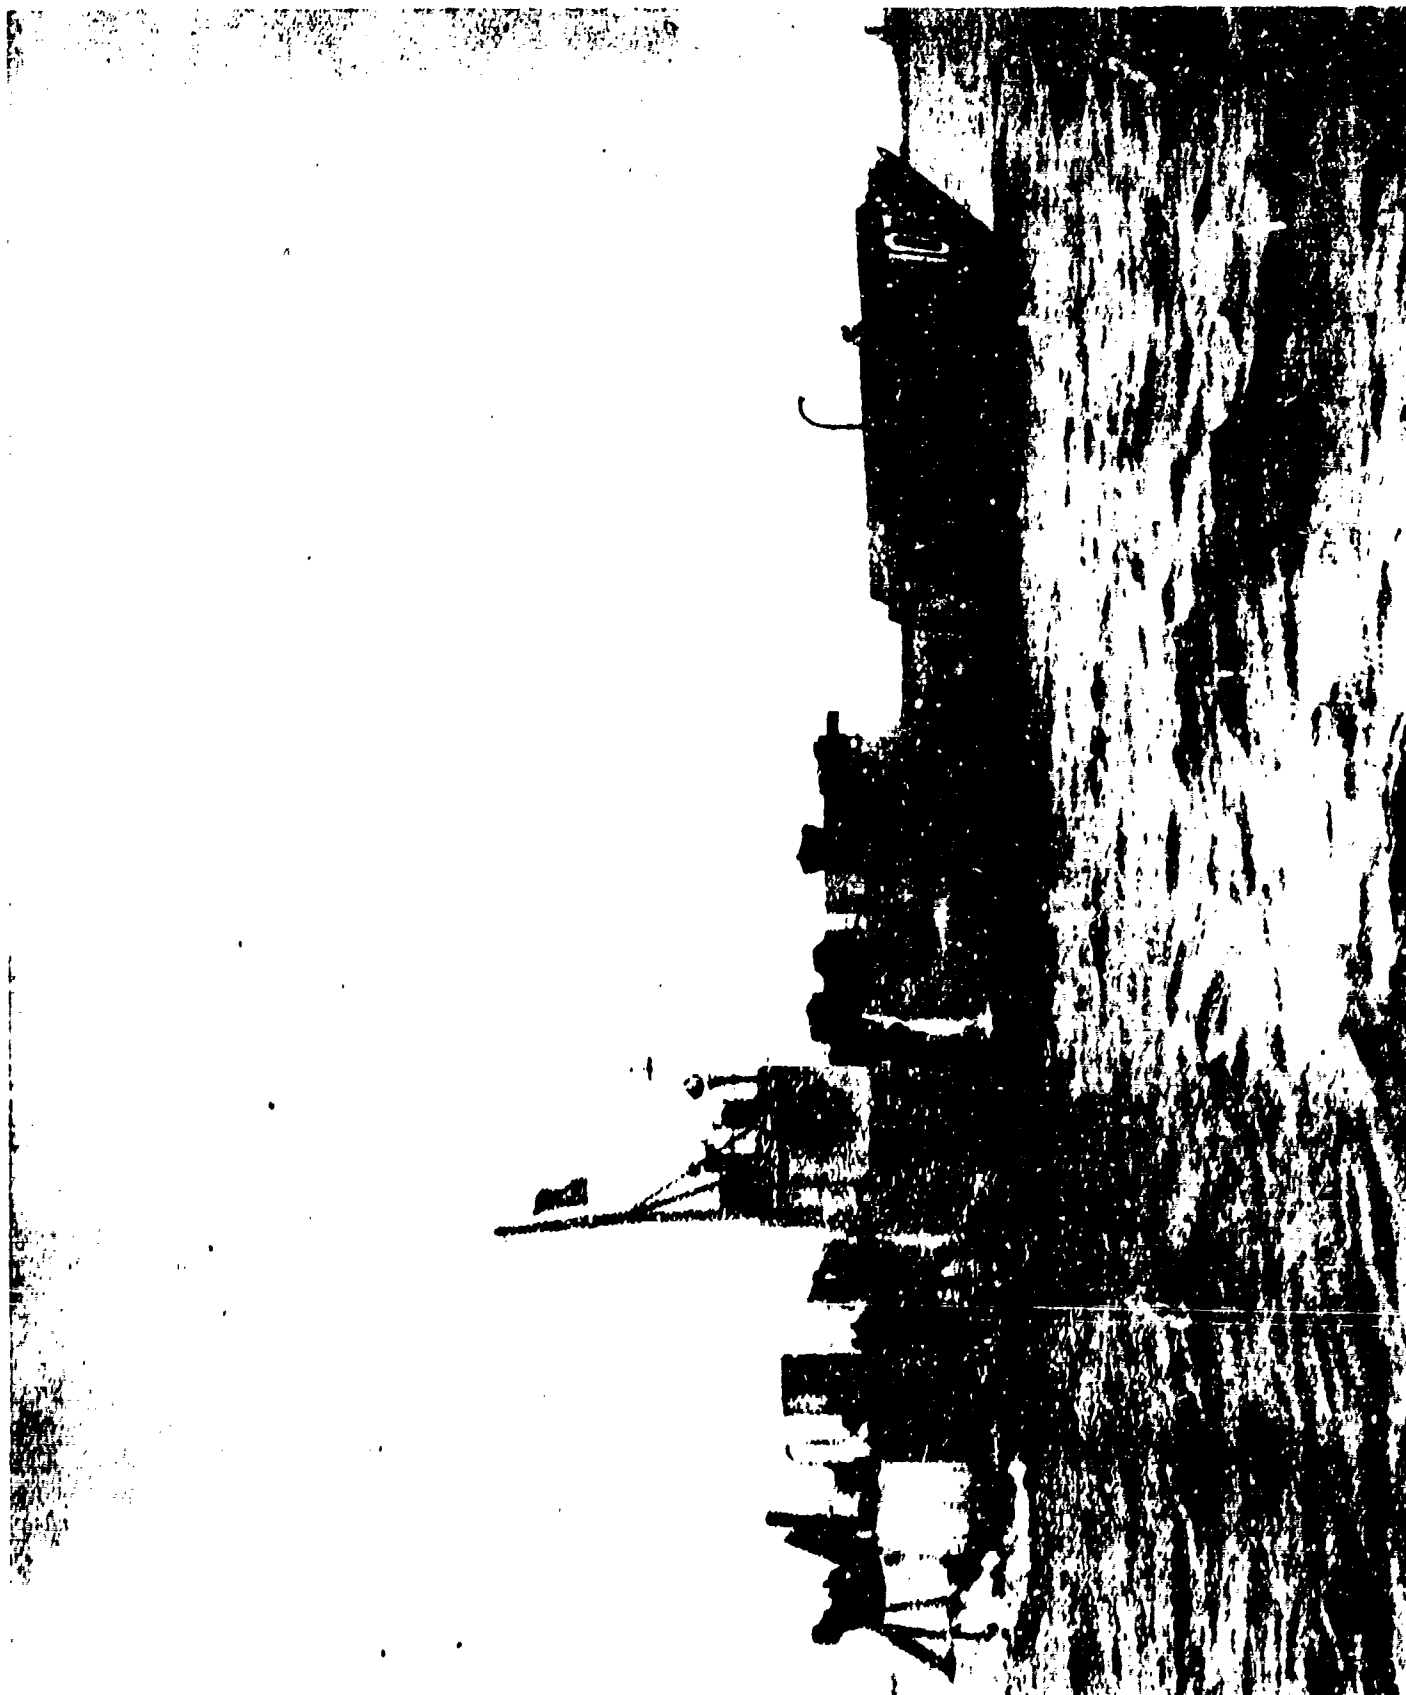
AA-CR-227-92-10. View from starboard quarter after Test A.

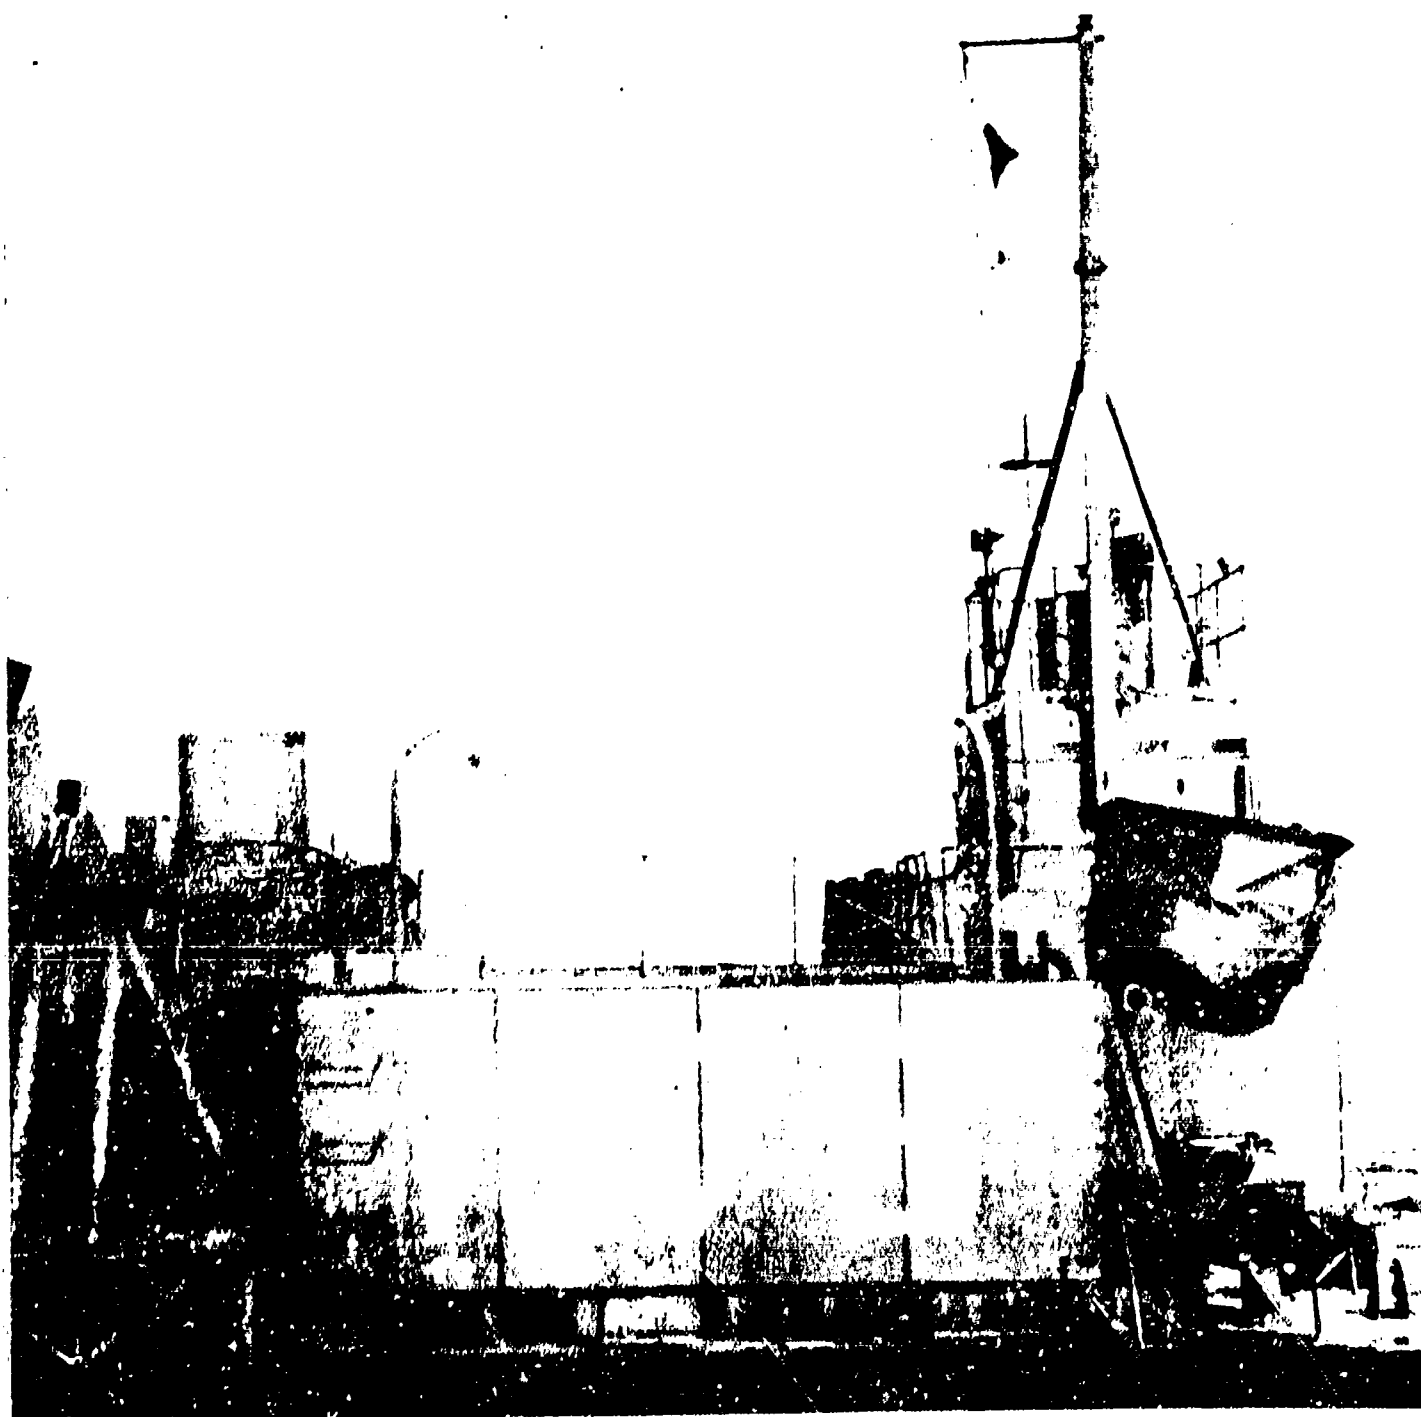
AA-CR-227-92-4. View from stern after Test B.

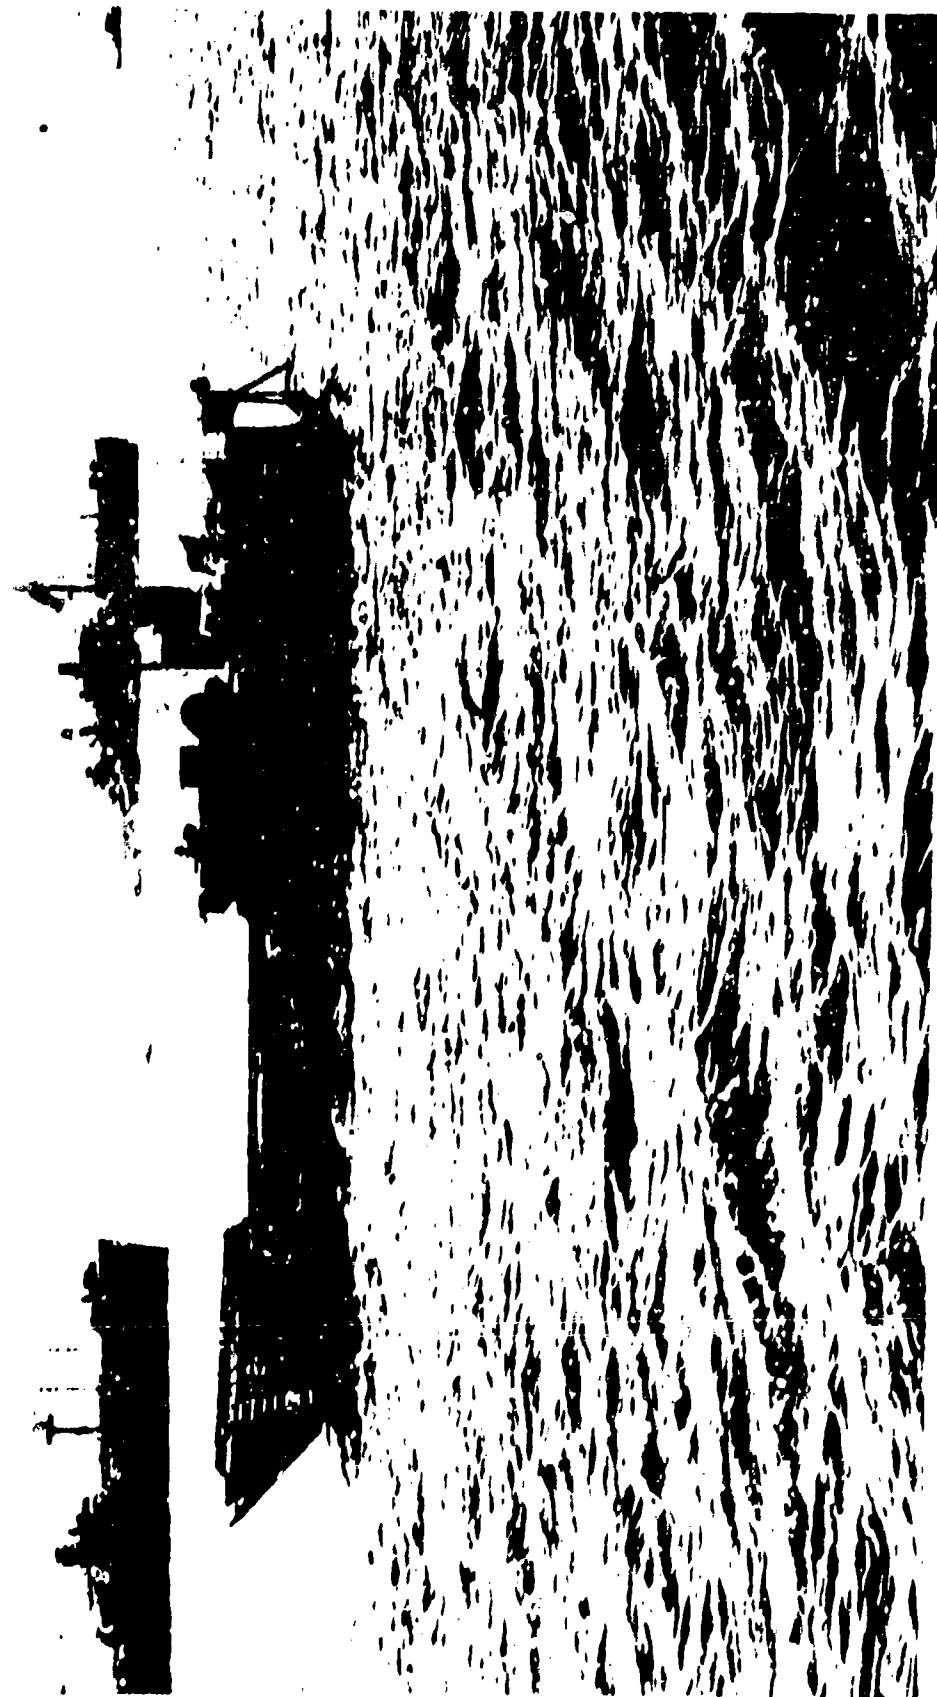
AA-CR-227-87-104. View from port beam after Test A.
